NASA-DoD Lead-Free Electronics Project

Joint Test Report - Final

December 2011

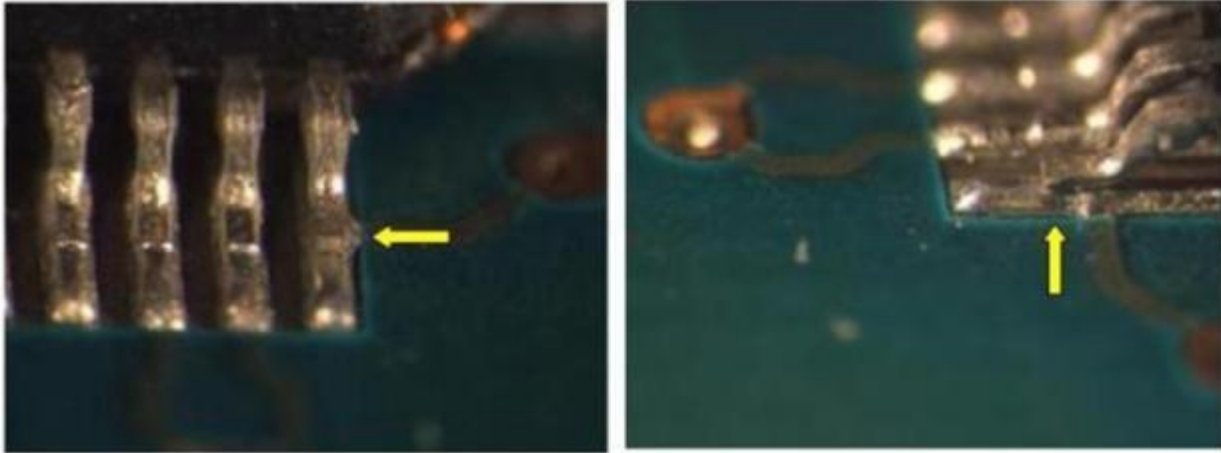
Component location U34 is a TQFP-144 component from SnPb manufactured (Batch C), soldered with SnPb on SnPb dip component finish. This component did not have a signal and failed before one complete cycle.

Figure 53 - TV21 U34; Optical Micrograph of Insufficient Solder Observed on Lead 72 at 49X Magnification

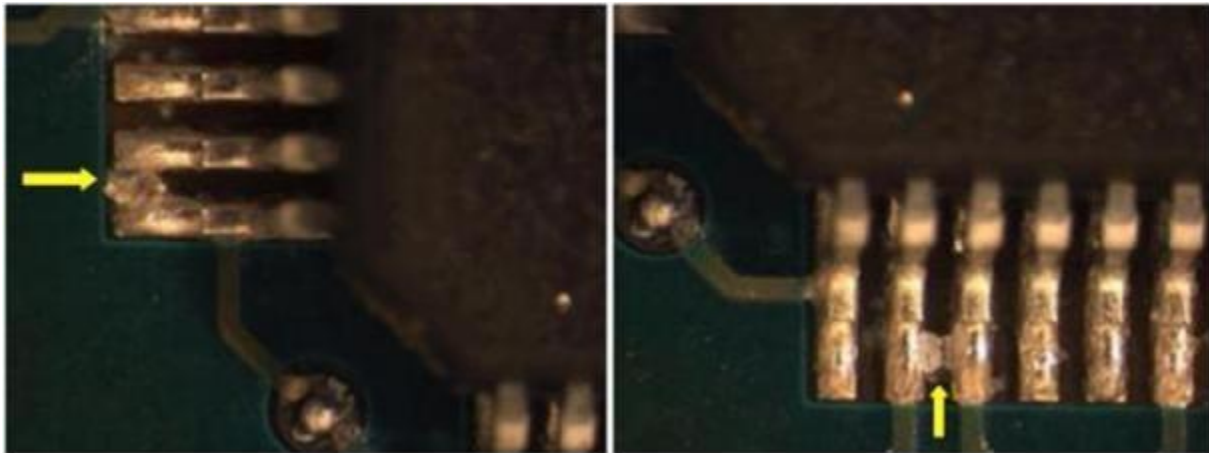
Figure 54 - TV21 U57; Optical Micrograph, Residue between Leads

Component location U57 is a TQFP-144 component from SnPb manufactured (Batch C), soldered with SnPb on SnPb dip component finish. This component failed at cycle one.

Figure 54 is the optical micrograph of residue that was found between leads in two locations. The image on the left shows residue between leads 35 and 36, magnified at 38X. The image on the right shows residue between leads 38 and 39, magnified at 38X.

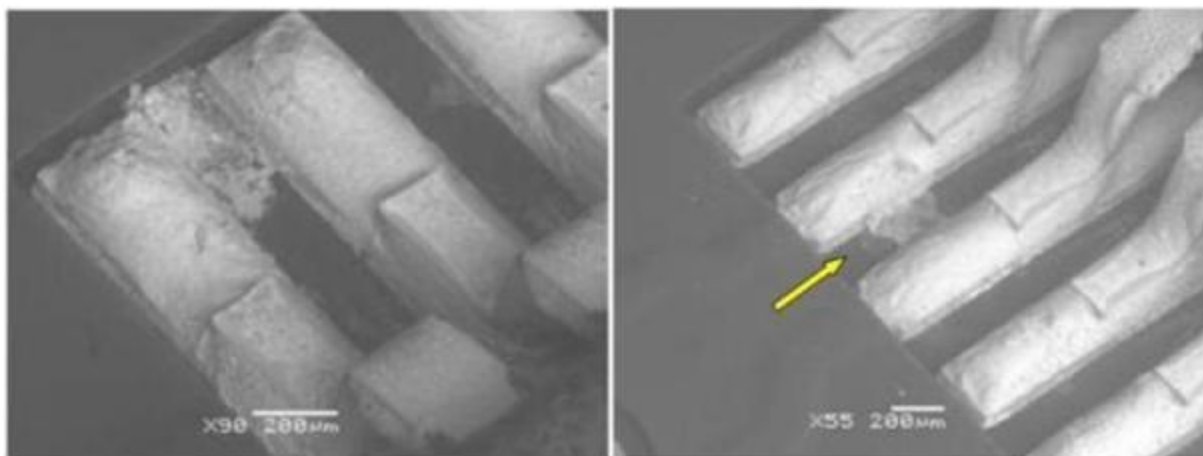
Figure 55 - TV21 U57; Optical Micrograph, Residue between Leads

Figure 55 shows Scanning Electron Microscope (SEM) images taken of the residue found from the images in Figure 54. The image on the left shows the residue that was found between leads 35 and 36, magnified at 90X. The image on the right shows the residue found between leads 38 and 39, magnified at 55X.

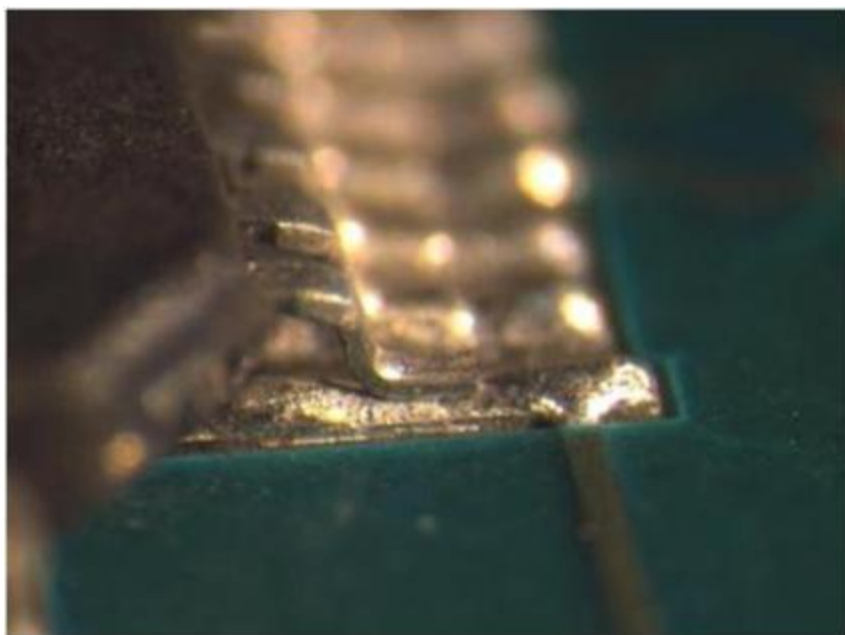
Figure 56 - TV21 U57; Optical Micrograph, Component Lead 1

The possible cause for the immediate failure at cycle one can be found in the Figure 56. The Optical micrograph shows component lead 1 does not contact solder on PWB pad at 49X magnification.

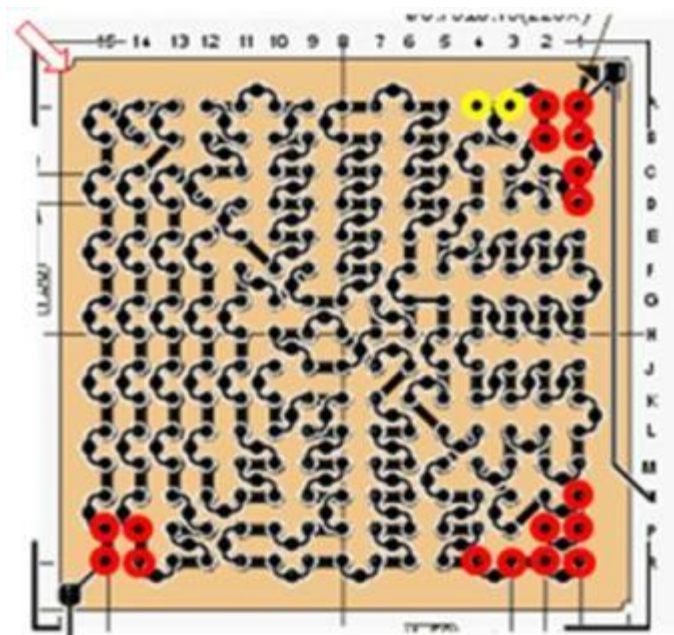
Figure 60 - TV23 U43; FA Results, BGA-225, Location U43

Component location U43 is a BGA-225 from the SnPb manufactured (Batch C), soldered with SnPb with SAC405 component finish located near the center of the test vehicle. This component failed at 120 cycles of combined environments. In Figure 60, yellow circles indicate solder joints with high resistance and red circles indicating failed solder joints that are open.

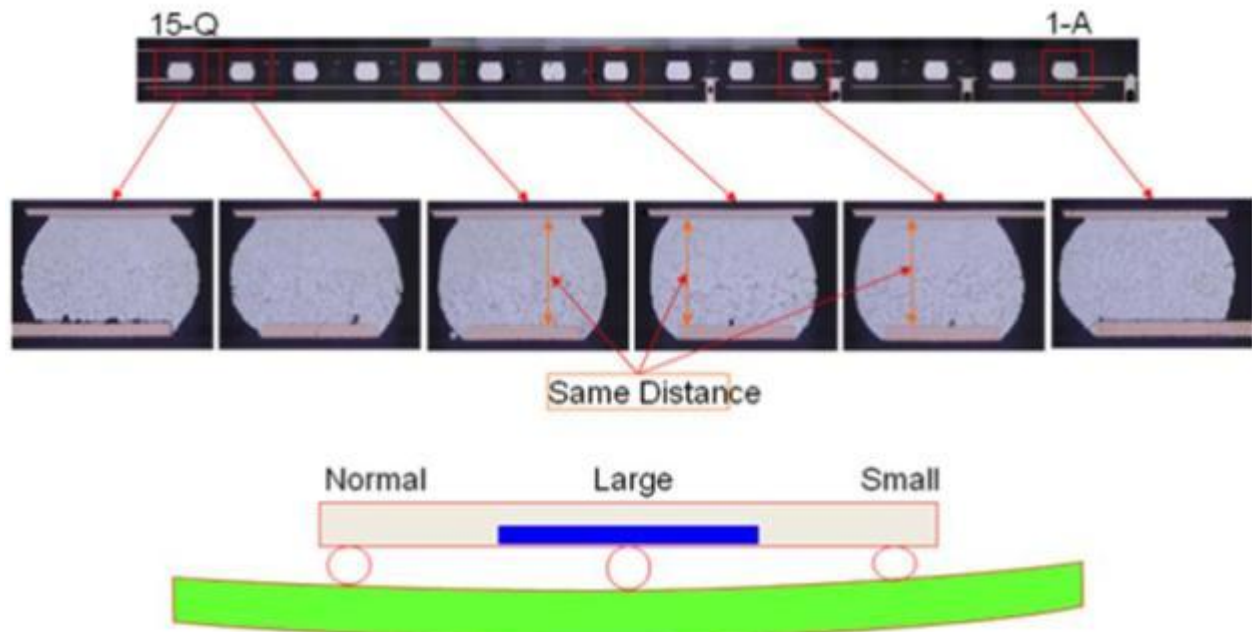
Figure 64 - TV23 U43; Cross-Sectional Micrographs Show Warping

In Figure 64 the distance between component and board at each sphere is almost the same under the chip in the center. The distance becomes smaller further to the end. Comparing the distance at [1-A] and [15-Q], [1-A] has smaller distance.

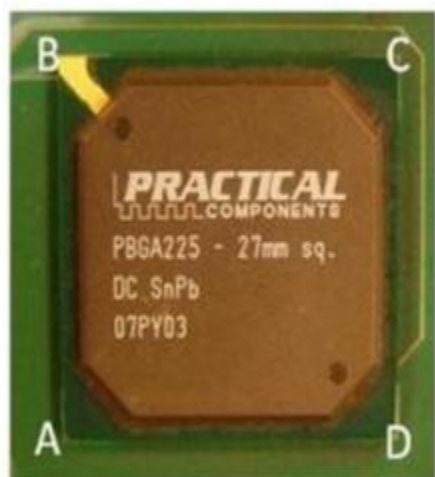
Figure 68 - TV117 U4; Orientation of the Corner Solder Balls

Component location U4 is a BGA-225 component from Pb-free manufactured (Batch G), soldered with SN100C solder paste on SnPb component finish. This component failed after twenty cycles. Figure 68 shows the orientation of the corner solder balls for the cross-sections in Figure 69.

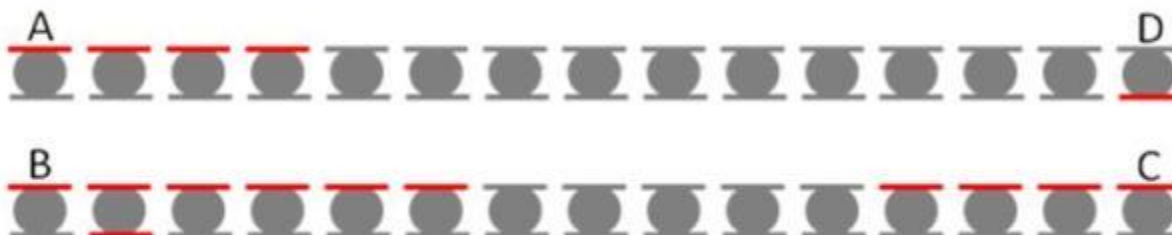
Figure 70 - TV117 U4; Diagram Showing Progression of Cracking in Component

There was a progression of cracking between sides A/D and B/C, which can be visually represented in Figure 70. Red on top of the solder ball is cracking observed at the component interface. Red on the bottom of the solder ball is cracking observed at the PWB pad interface. Red on both the top and bottom of the solder ball is cracking observed at both the component and PWB pad interface. No red indicates an intact solder joint.

For this BGA-225 component, cracking was observed on both the second and third rows in from the perimeter row. No cracking was observed on solder balls beneath the component die.

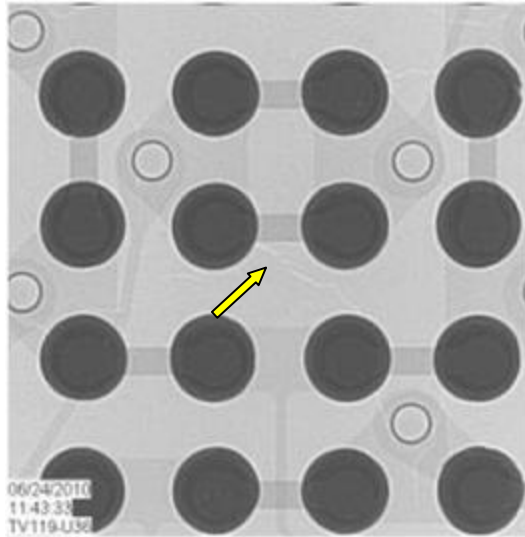
Figure 71 - TV119 U36; X-Ray Image, CSP-100

Component location U36 is a CSP-100 component from lead-free manufactured (Batch G), soldered with SN100C solder paste on SAC105 component finish. This component was surrounded by components that fell off during testing and failed after 233 cycles.

Figure 71 is an x-ray image of the center region of the CSP-100 component in location U36. The PCB solder mask has a crack and is not homogeneous.

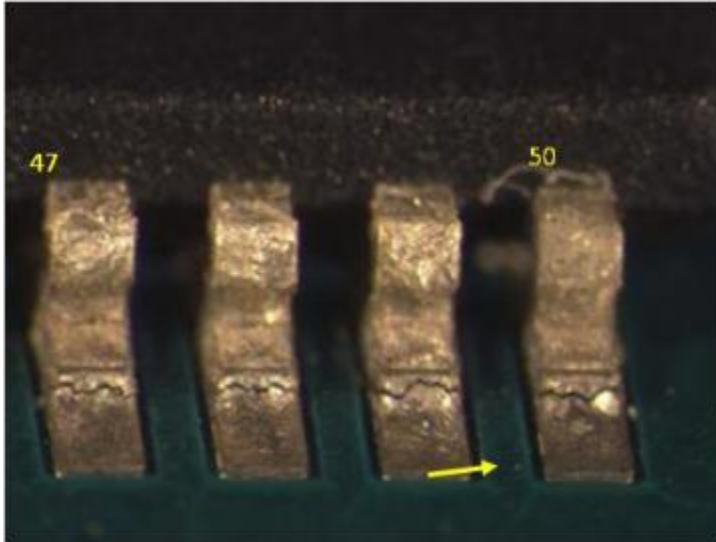
Figure 74 - TV119 U39; Optical Micrograph at 49X Magnification

Component location U39 is a TSOP-50 component from lead-free manufactured (Batch G), soldered with SN100C solder paste on SnPb component finish. This component was surrounded by components that fell off during testing and failed after 318 cycles. In Figure 74, an optical micrograph at 49X magnification showing cracked solder joints and cracks in the solder mask between leads 47 and 50.

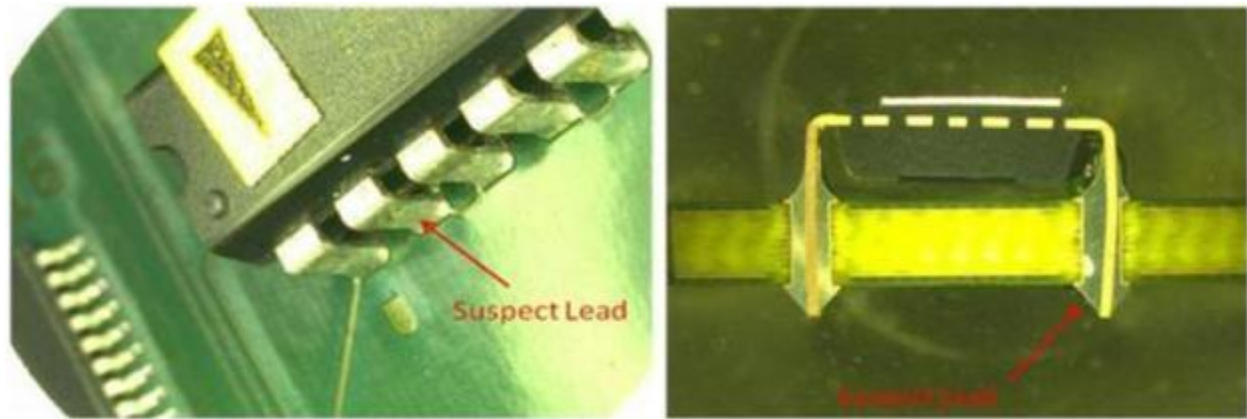
Figure 79 - TV140 U11; Optical Micrograph

Component location U11 is a PDIP-20 from SnPb rework (Batch B), soldered with SnPb on SnPb component finish. This component had a damaged pad from the rework process and failed after 398 cycles. For the optical micrograph in Figure 79, on the left shows the suspect lead. Cross-sectional micrograph on the right is the suspect lead.

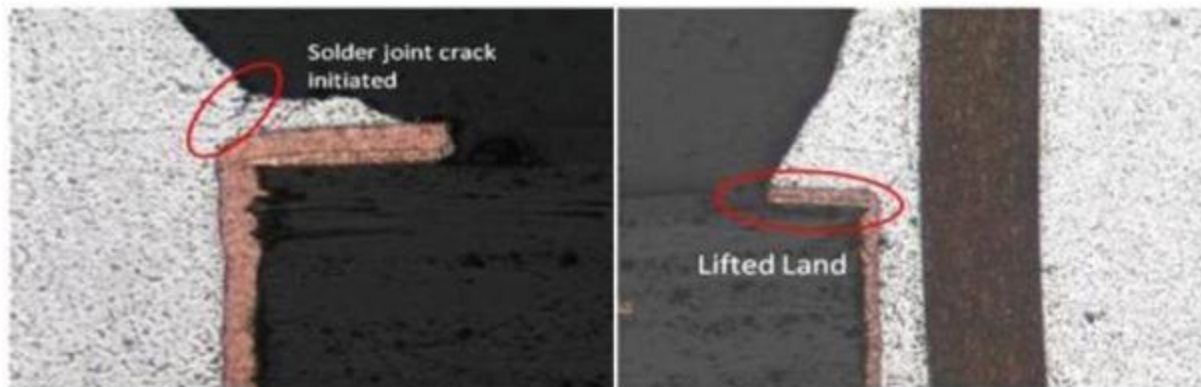
Figure 80 shows the cross-sectional micrographs of the suspect lead in the PDIP-20 component showing solder joint crack initiation and lifted land.

Figure 80 - TV140 U11; Cross-Sectional Micrographs, Suspect PDIP-20 Lead

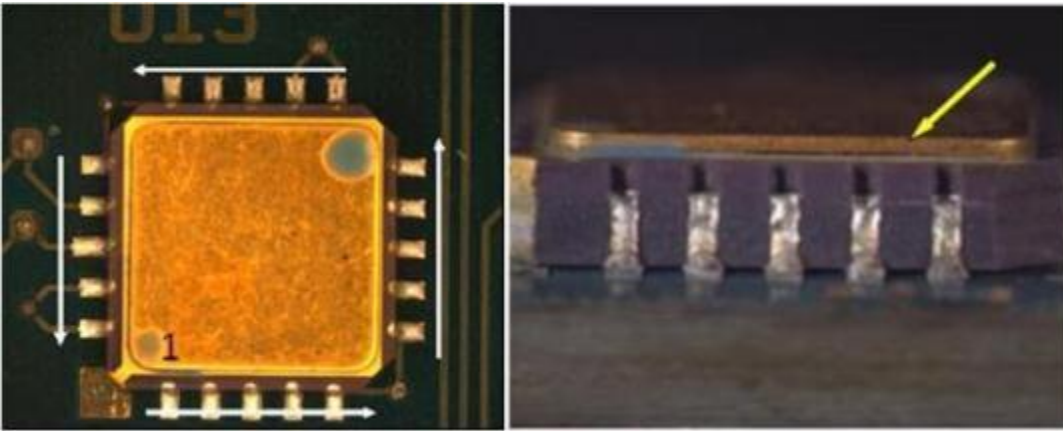
Figure 81 - TV142 U13; Optical Micrograph, CLCC Package Lead

Figure 81, optical micrograph, on the left shows the CLCC package lead numbering. Micrograph on the right shows an improperly sealed lid on the side for leads 1 – 5 where lead 1 is on the left at 19X magnification.

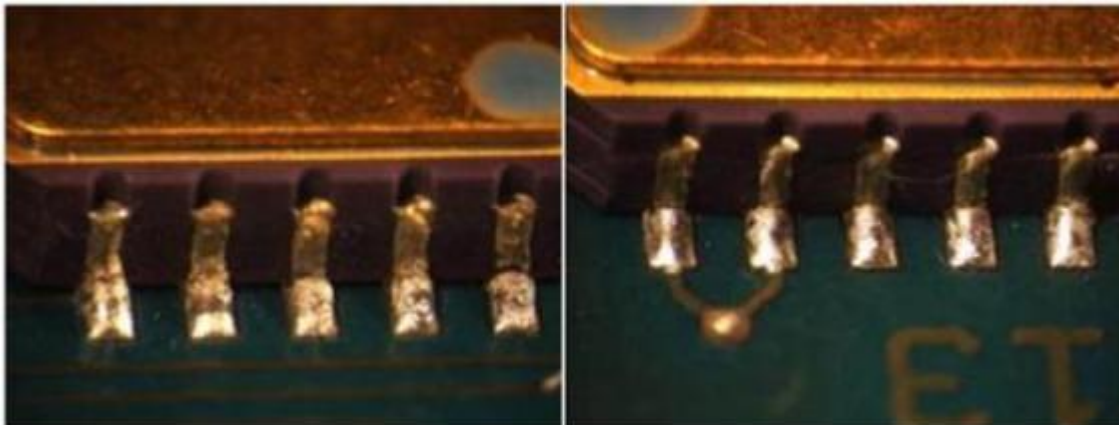
Figure 82 - TV142 U13 Optical Micrographs of CLCC-20 Leads at 24X Magnification

For Figure 82, on the left are leads 6 – 10 starting with lead 6 on the left and on the right are leads 11 – 15 starting with lead 11 on the left. Minor solder cracking is visible.

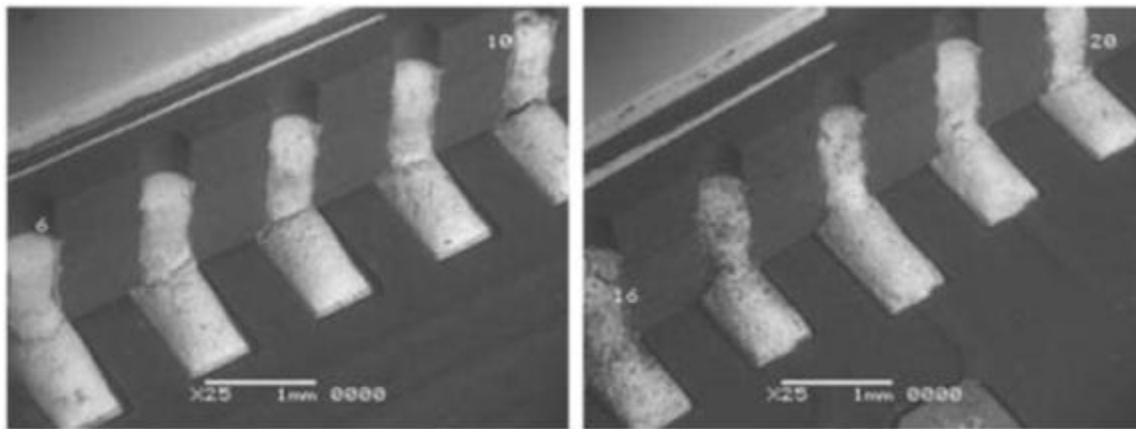
Figure 84 - TV142 U13 SEM Images of Component at 25X Magnification

In Figure 84 on the left are leads 6 – 10 which have some visible solder cracks and on the right are leads 16 – 20 and do not have solder cracks.

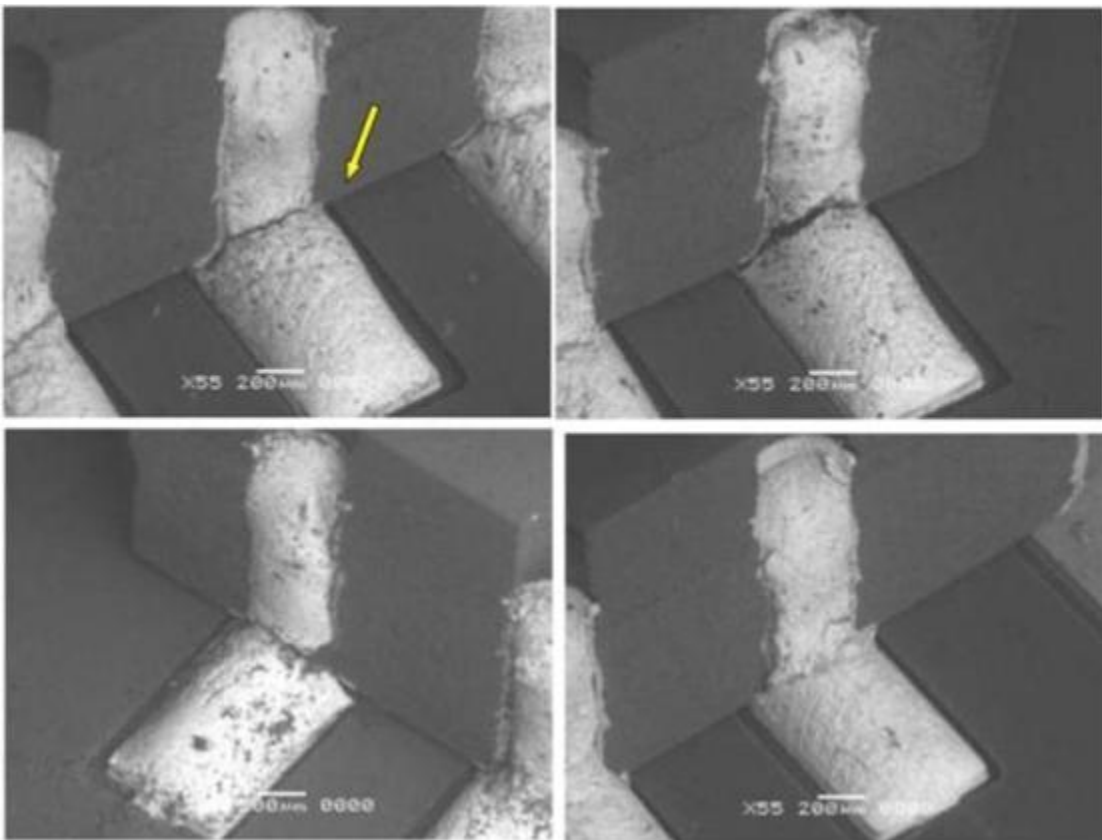
Figure 85 - TV142 U13 SEM Images of Selected Leads at 55X Magnification.

In Figure 85, the upper left image is lead 8 where the arrow indicates a solder crack. The upper right image is lead 10 where a solder crack is also visible. The lower left image is lead 11 and the lower right image is lead 20.

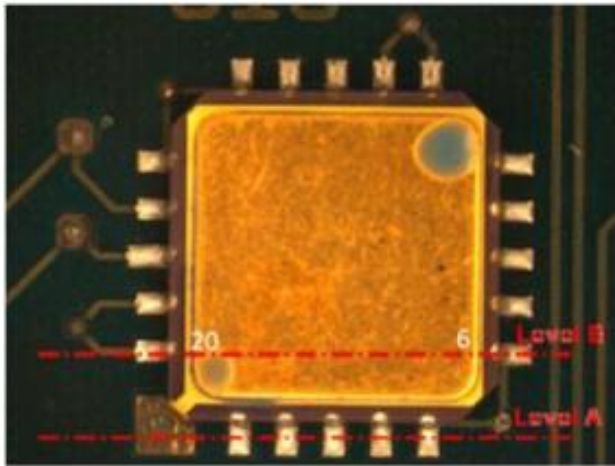
Figure 86 - TV142 U13; CLCC-20 Component

Figure 86 is an optical micrograph indicating the grinding levels of U13 CLCC-20 component.

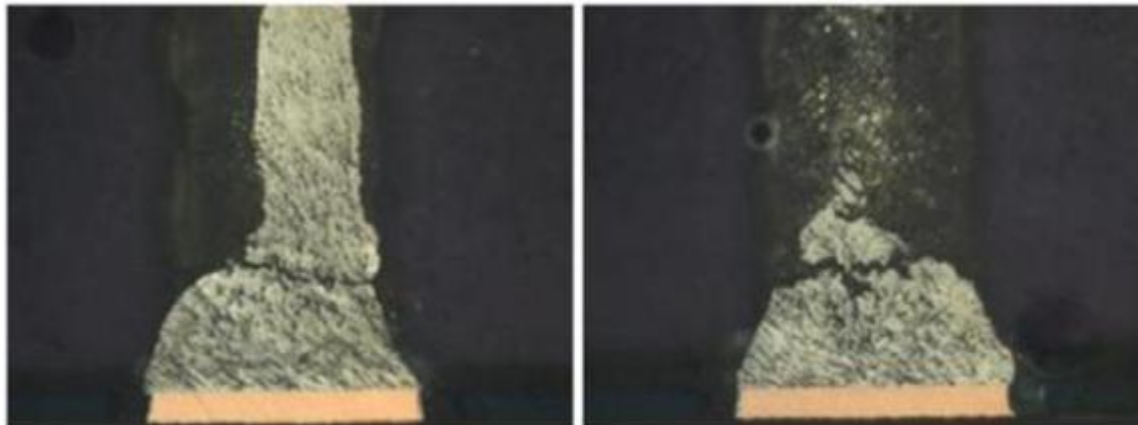
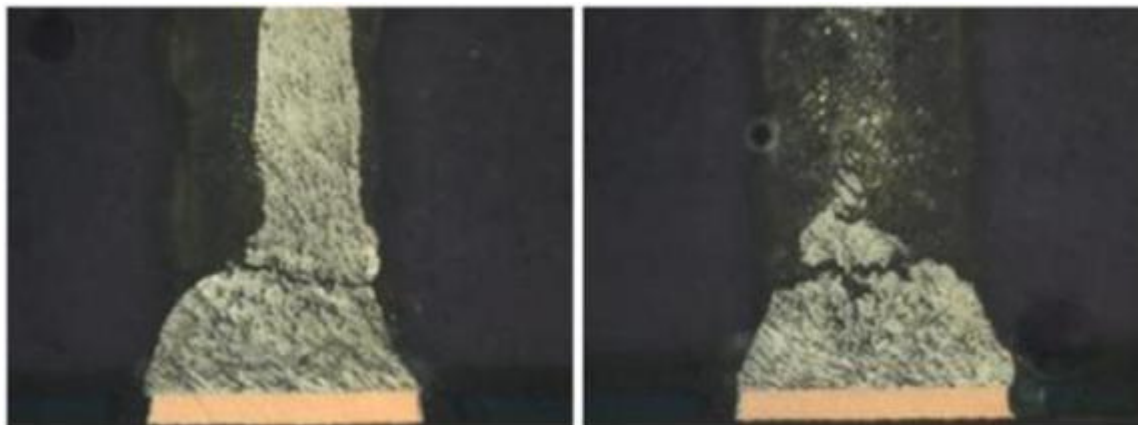
Figure 87 - TV142 U13; Cross-Sectional Micrographs of Lead 1 and Lead 5

Figure 87, cross-sectional micrographs of lead 1 (left) and lead 5 (right) solder joints, grinding level A, at 136X magnification.

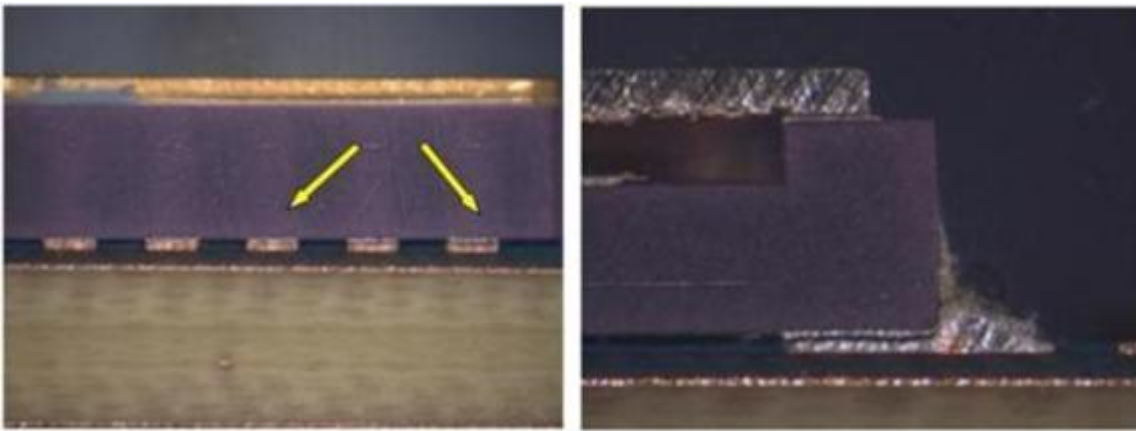
Figure 88 - TV142 U13; Cross-Sectional Micrograph

Figure 88, cross-sectional micrograph, on the left shows grinding level A of leads 1 – 5 where the arrows indicate separation of the solder joints from the copper pads at 24X magnification. Micrograph on the right is lead 6 at 38X magnification just prior to grinding to level B.

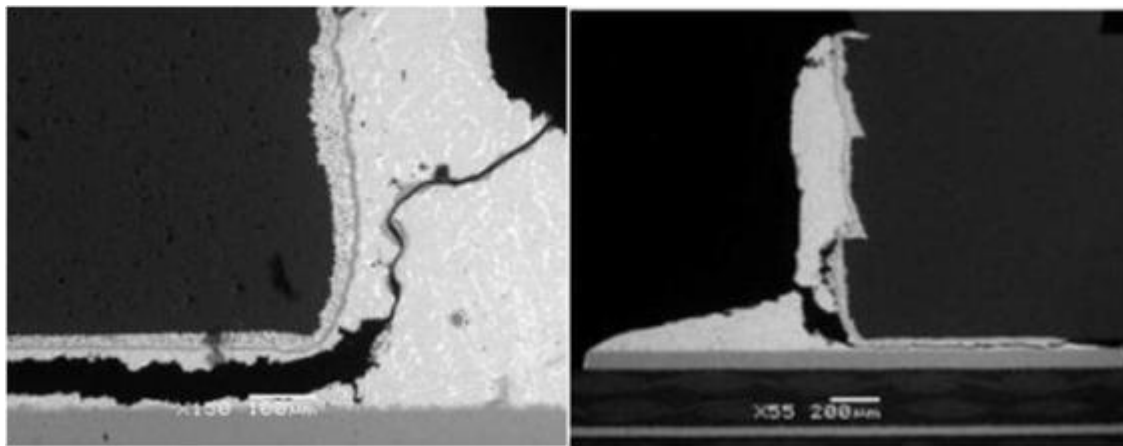
Figure 89 - TV142 U13; SEM Image

Figure 89, SEM image, on the left is the cross-section of lead 6 after grinding to level B at a 150X magnification. SEM image on the right is the cross-section of lead 20 after grinding to level B at 55X magnification.

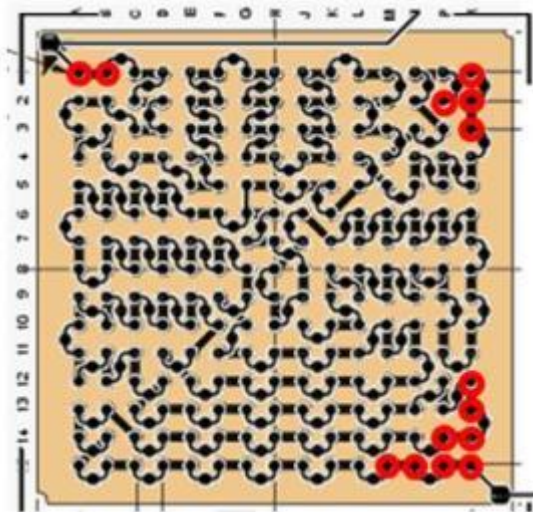
Figure 90 - TV158 U6; FA Results

Component location U6 is a reworked SnPb BGA-225 component soldered with SnPb solder paste, removed and replaced with a SAC405 BGA-225 component soldered with SnPb solder paste on an ENIG PWB. This component failed during the first cycle.

In Figure 90, the red circles indicate failed solder joints that are open.

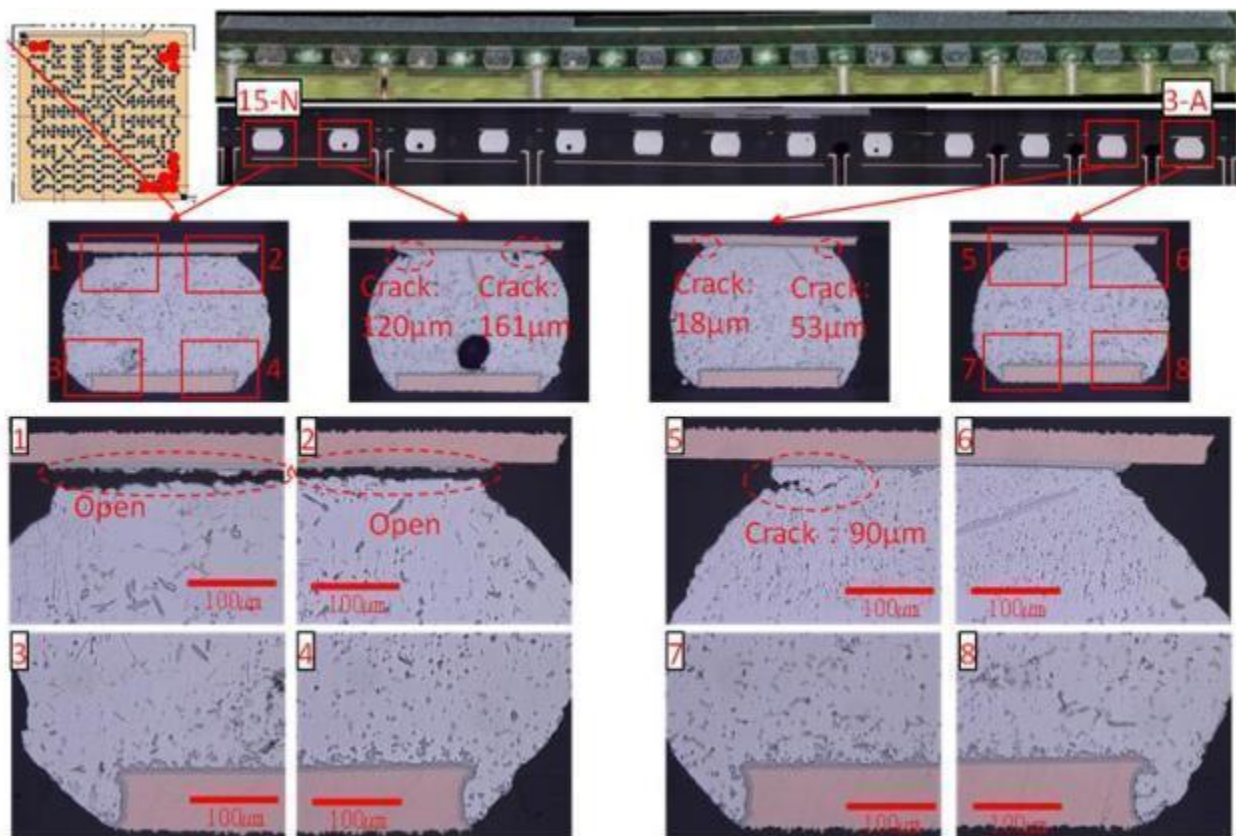
Figure 91 - TV158 U6; Cross-Sectional Micrographs

The cross-sectional micrographs in Figure 91 show different solder structure in lands on board (7, 8) and lands on component (5, 6). Cracking to open along component land observed at 15-N.

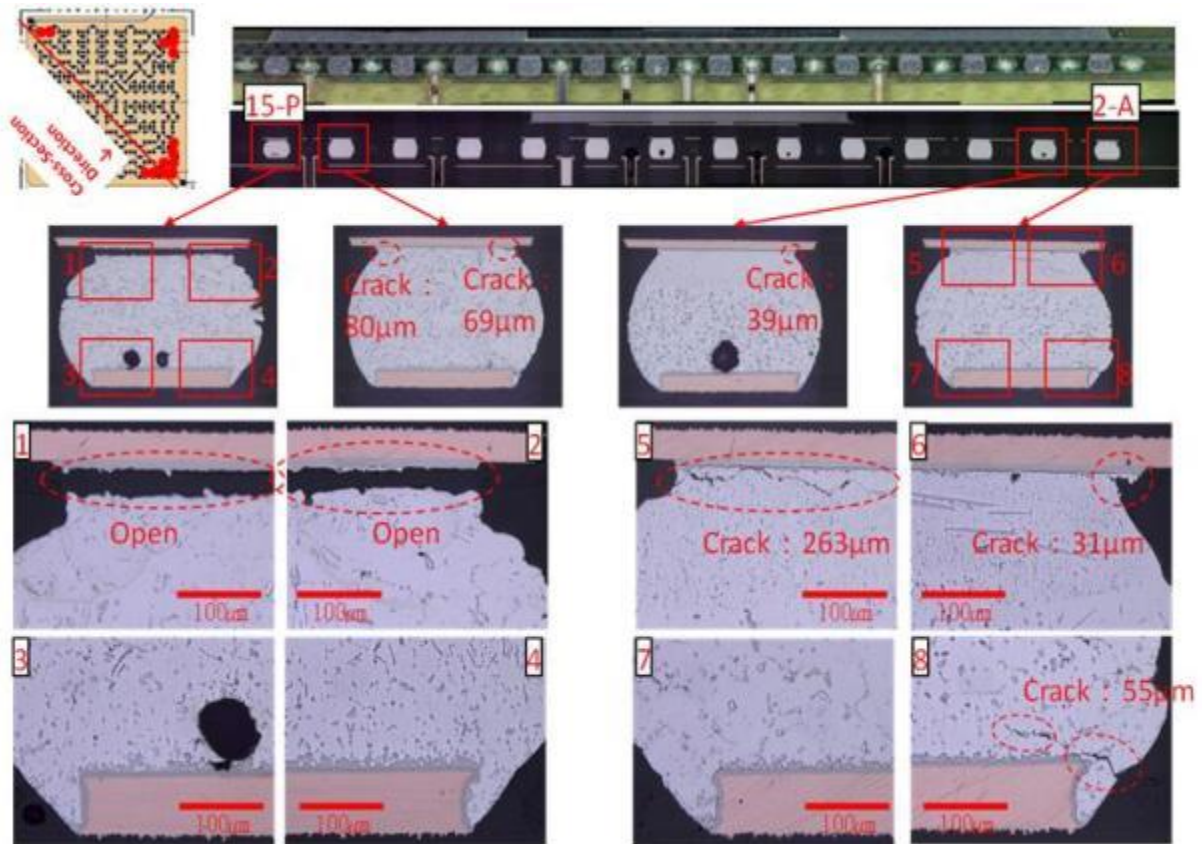
Figure 92 - TV158 U6; Cross-Sectional Micrographs

Figure 92 cross-sectional micrographs show different solder structure in lands on board (1, 2, 7, 8) and lands on component (3, 4, 5, 6). Cracking to open along PWB land found at 15-P.

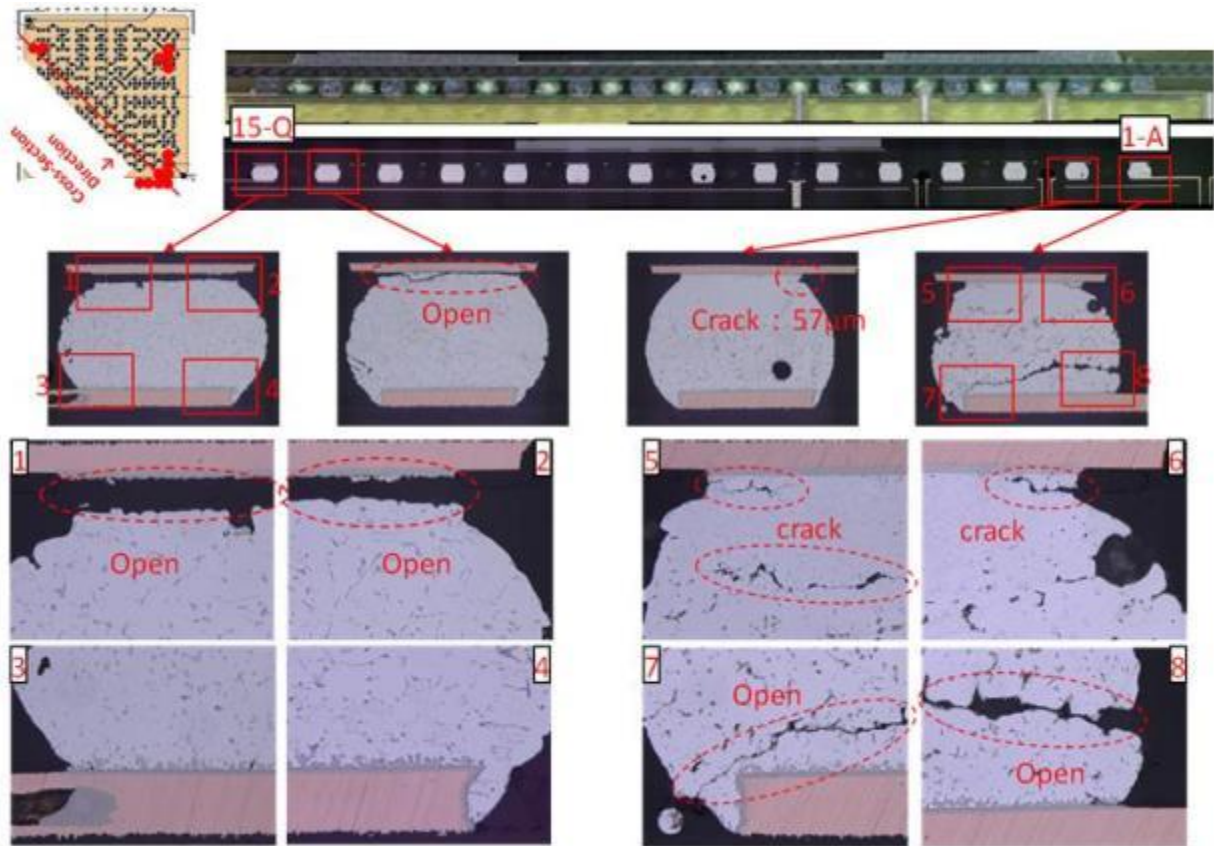
Figure 93 - TV158 U6; Cross-Sectional Micrographs

Cross-sectional micrographs in Figure 93 show different solder structure in lands on board (7, 8) and lands on component (5, 6). Cracking to open inside solder found at 1-A. Open joint along land on component found at 15-N.

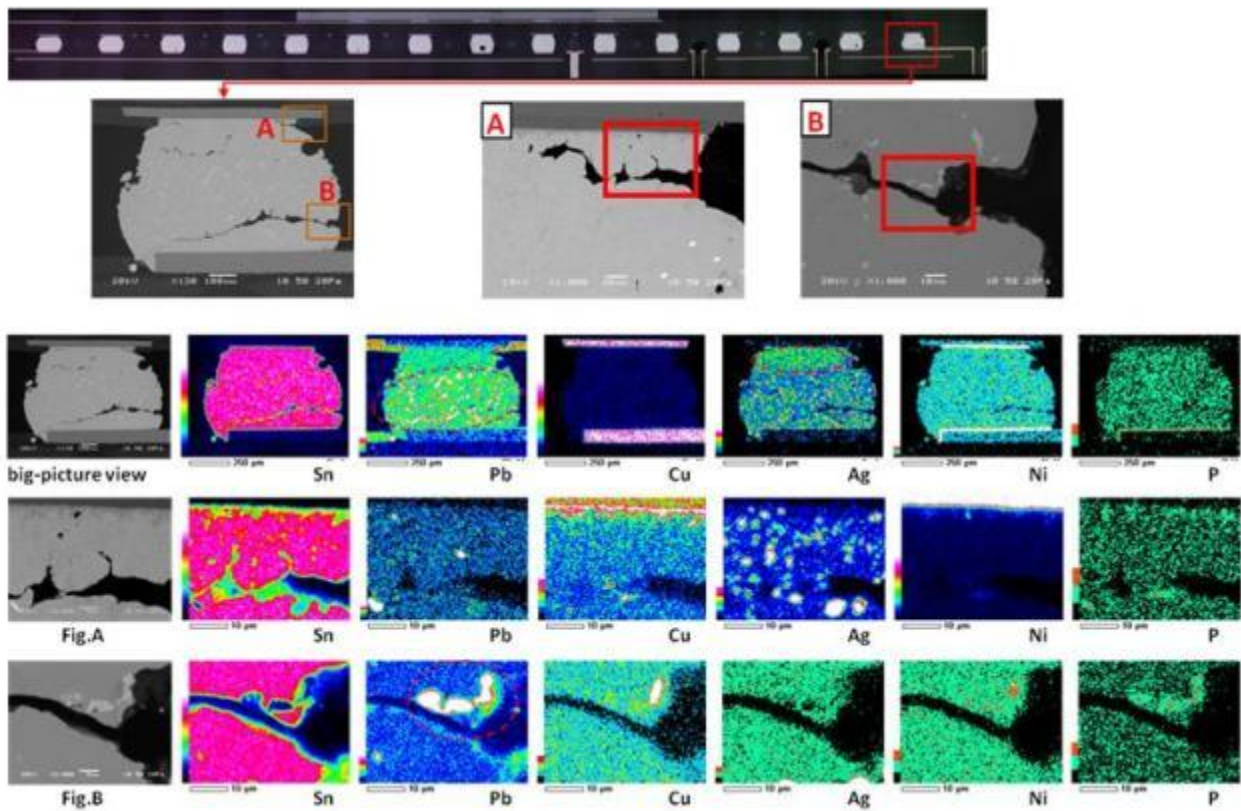
Figure 94 - TV158 U6; SEM Mapping

SEM mapping in Figure 94 shows segregation of Ag around land on component and segregation of Pb around PWB land. Higher concentrations of Pb detected in the cracking / breaking area.

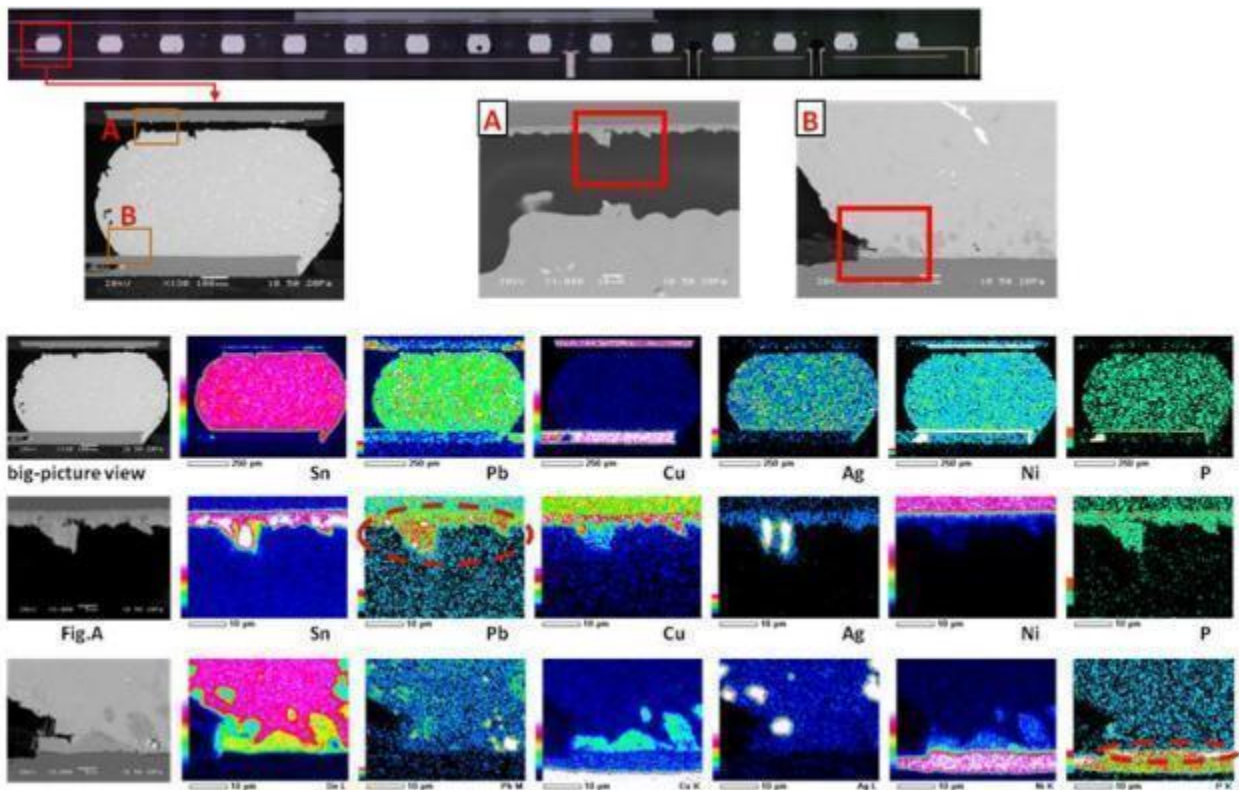
Figure 95 - TV158 U6; SEM Mapping

SEM mapping in Figure 95 shows solder is well blended over all except around component land where higher levels of Pb and cracking were found. Segregation of P from the ENIG board finish, however, no cracking detected.

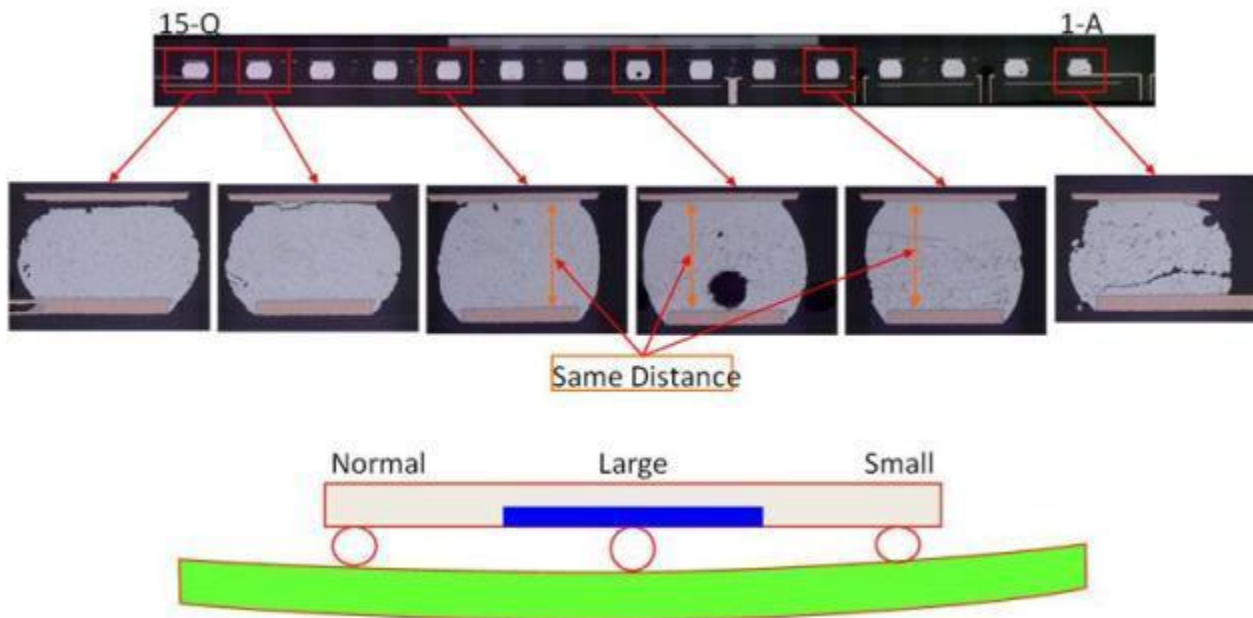
In Figure 96 the distance between component and board at each sphere is almost the same under the chip in the center. The distance becomes smaller further to the end. Comparing the distance at [1-A] and [15-Q], [1-A] has smaller distance.

Figure 96 - TV158 U6; Cross-Sectional Micrographs Show Warping on BGA-225

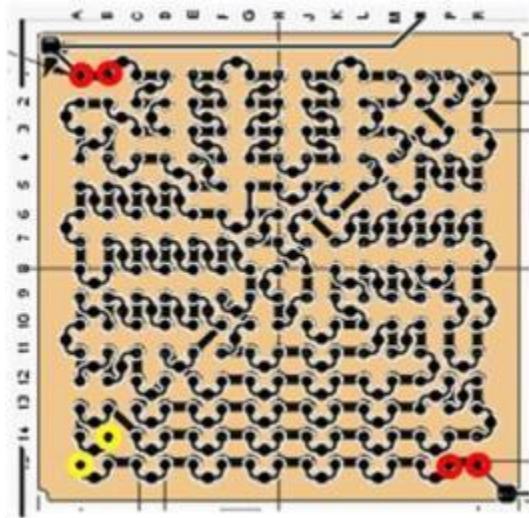
Figure 97 - TV180 U21; FA Results

Component location U21 is a reworked BGA-225 soldered with SAC305 on SAC405 component finish and replaced with SAC405 BGA-225 soldered with flux only. This component failed on cycle one and was reworked prior to combine environments testing.

In Figure 97 the yellow circles are solder joints with high resistance and red circles are failed solder joints that are open.

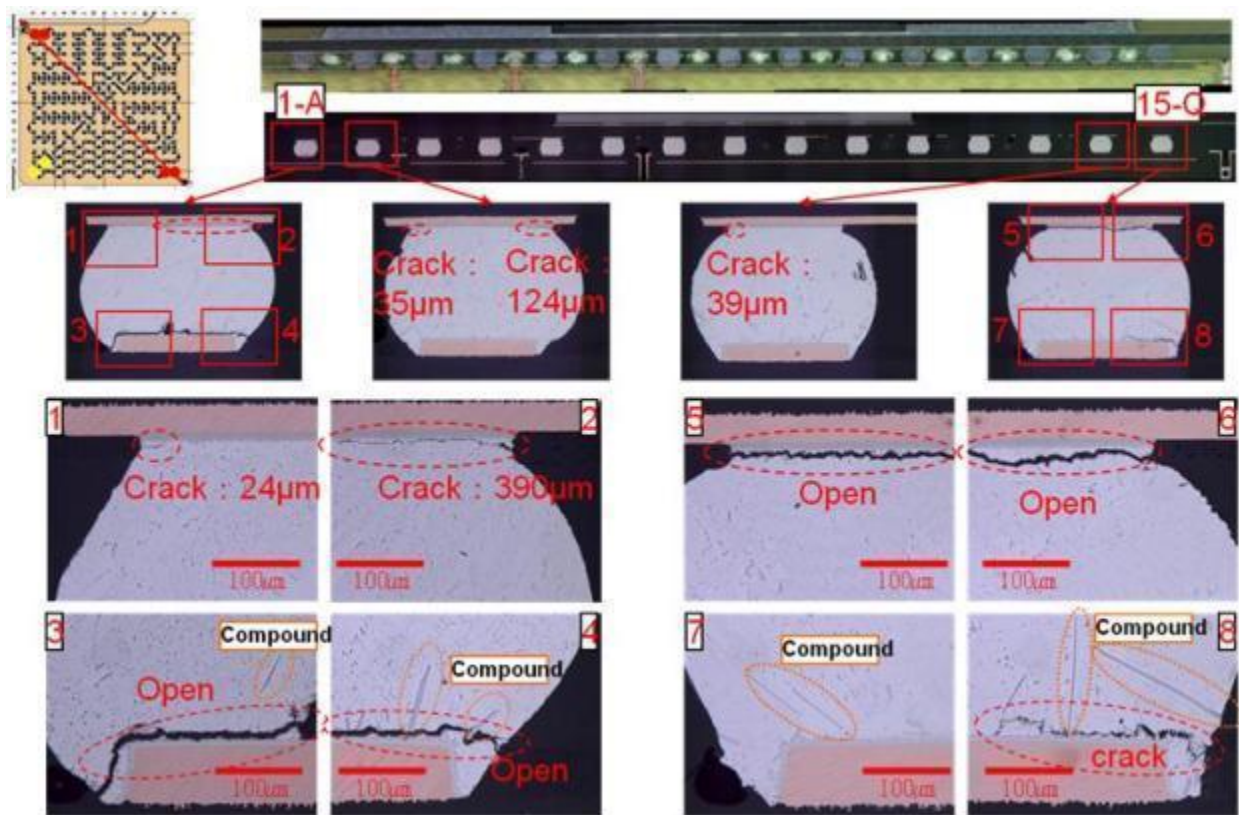
Figure 99 - TV180 U21; Cross-Sectional Micrographs

In Figure 99 the cross-sectional micrographs show cracking to open solder joints around both land on board and component (3, 4, 5, 6). Large intermetallic compounds observed around land on board (3, 4, 7, 8).

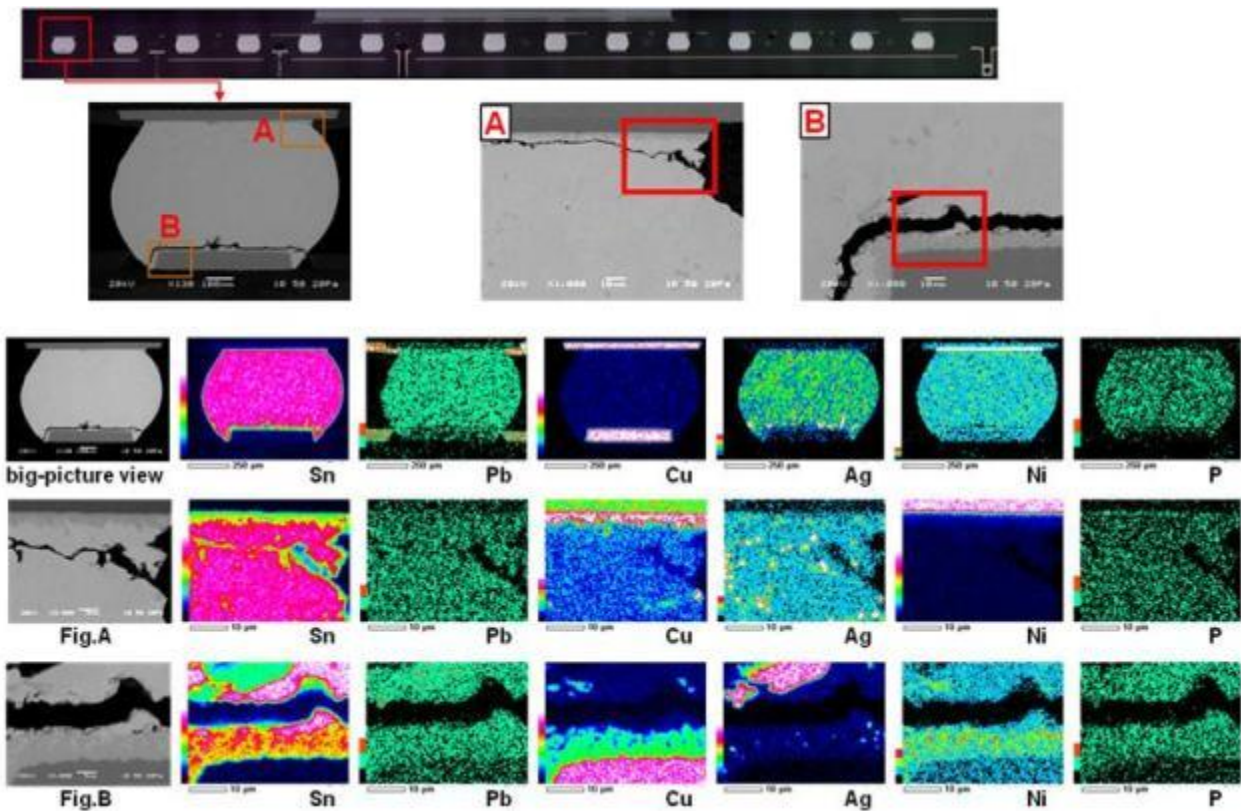
Figure 100 - TV180 U21; SEM Mapping

SEM mapping in Figure 100 shows cracks inside solder as well as cracking to open between IMC and solder, or inside solder.

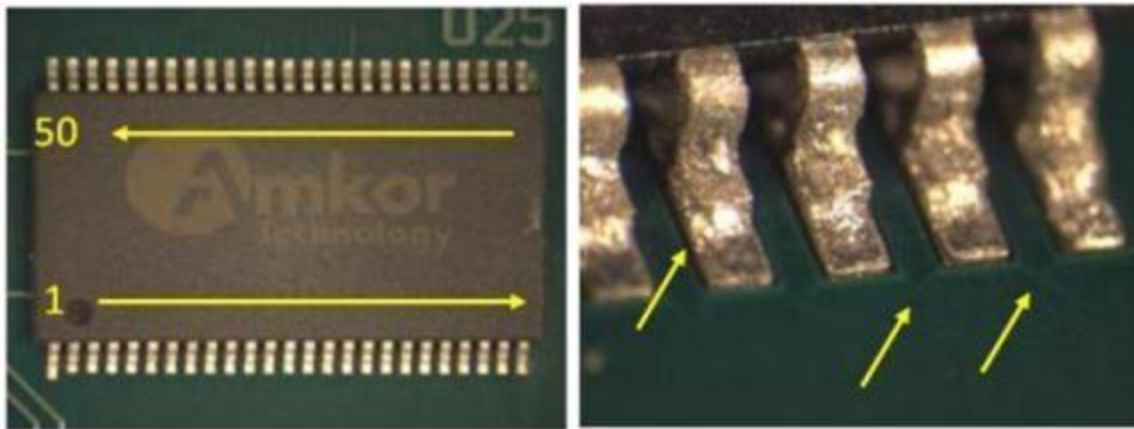
Figure 106 - TV181 U25; Optical Micrographs

In Figure 106 the optical micrograph on the left is the lead numbering and the image on the right is of leads 21-25. The arrows indicate cracked solder mask and the arrow on lead 22 indicates a solder disturbance at 49X magnification.

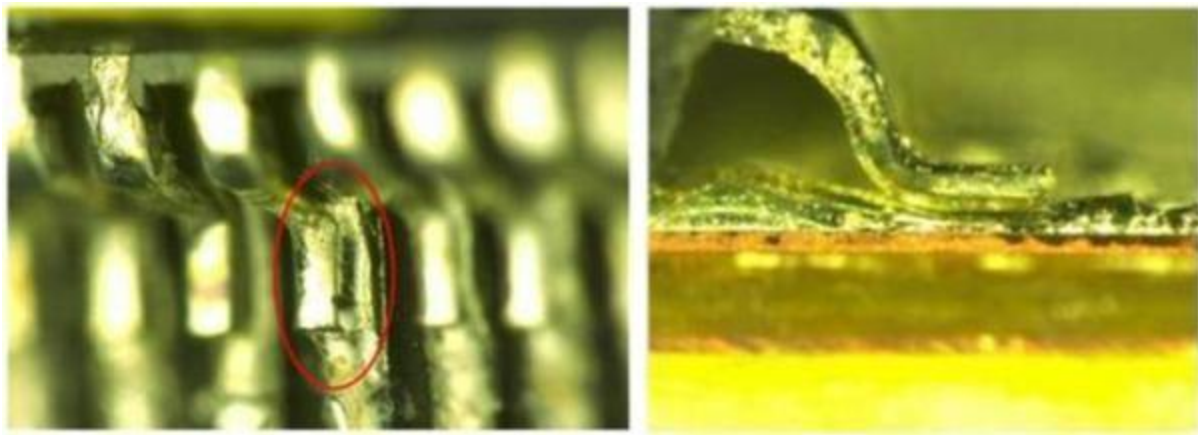
Figure 112 - TV183 U 41; Optical Micrographs of Suspect Lead

Figure 112 shows inadequate solder joint resulting in no connection between the lead and the pad.
